## ACOUSTICAL PERFORMANCE TEST REPORT

**Climate Seal™**

**TYPE: Dual Window System Consisting of a  
Wood Double Hung Window with the One-Lite  
Magnetic Seal Interior Storm Window System**

| Report No: | 01-46456.01 |

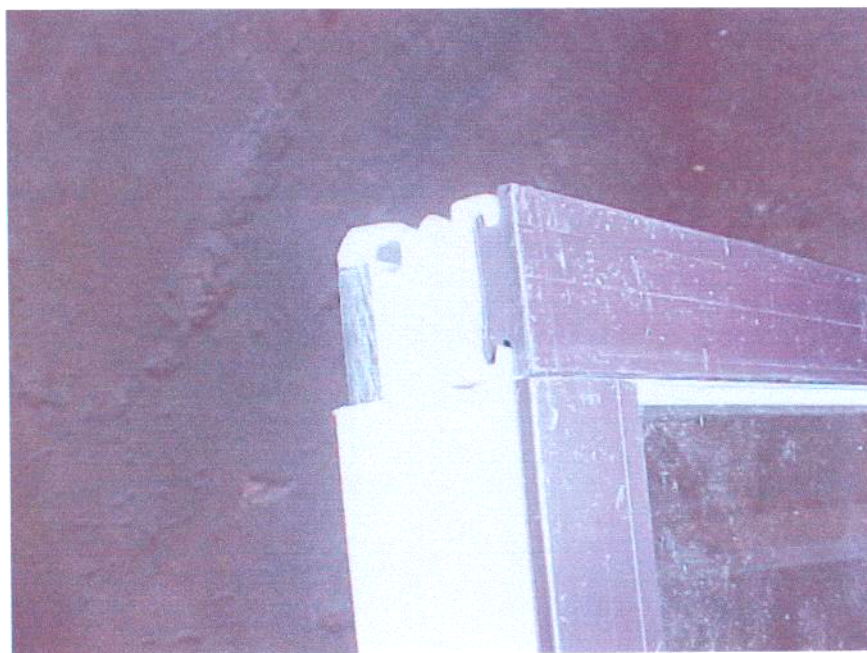
**Magnetic Seal Surface of Storm Panel**

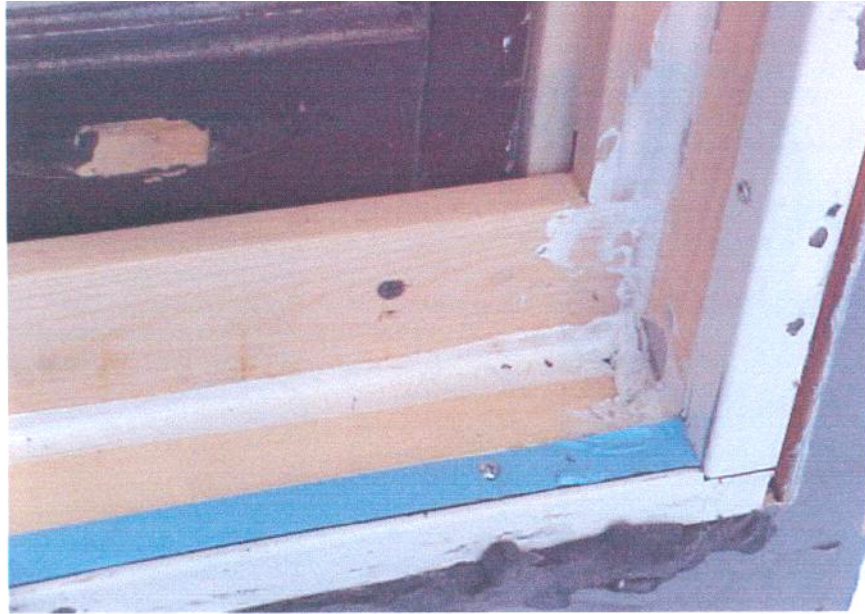
**Sheet Metal Angle Mounted to Test Sample  
for Frame Mount Application**

A 1" x 1" sheet metal angle was faced with foam tape on one surface. The angle was then screwed to the prime window frame around the interior perimeter face with the foam tape separating the prime window frame and the angle. The panel was fastened to the angle with the use of 1" wide magnets located on all four members of the storm window. The glass to glass air space between the top sash of prime window and the storm window was five inches. The glass to glass air space between the bottom sash of the prime window and the storm window was three inches.

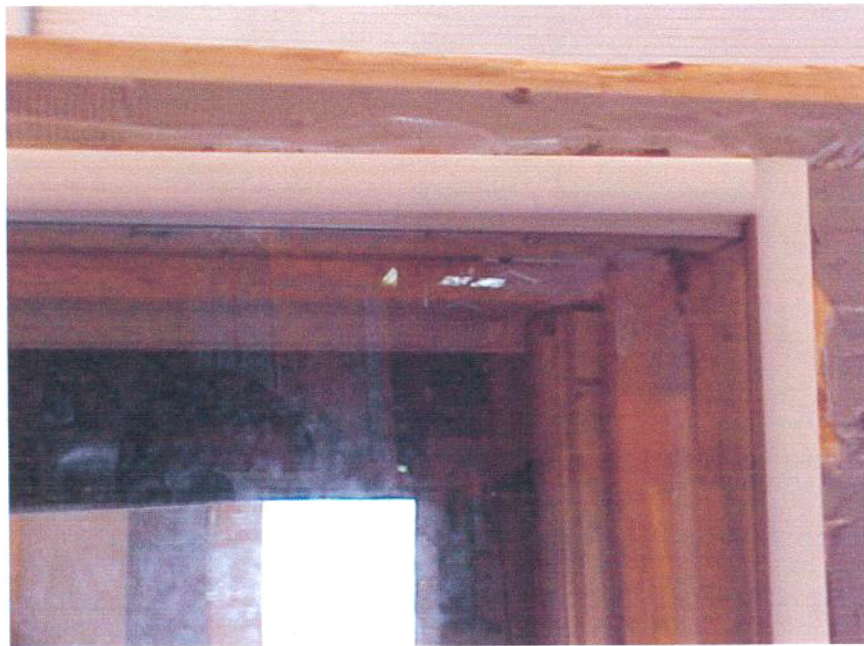
**Frame Mount Storm Window Installed onto Sheet Metal Angle**
