ACOUSTICAL PERFORMANCE TEST REPORT

Climate Seal™

**TYPE: Dual Window System Consisting of Three
Vinyl Clad Wood Casement Windows Muller Together
with the Magnetic Seal Interior Storm Window System**

Report No:	01-46458.01
Test Date:	07/31/03
Report Date:	09/26/03
Expiration Date:	07/31/07

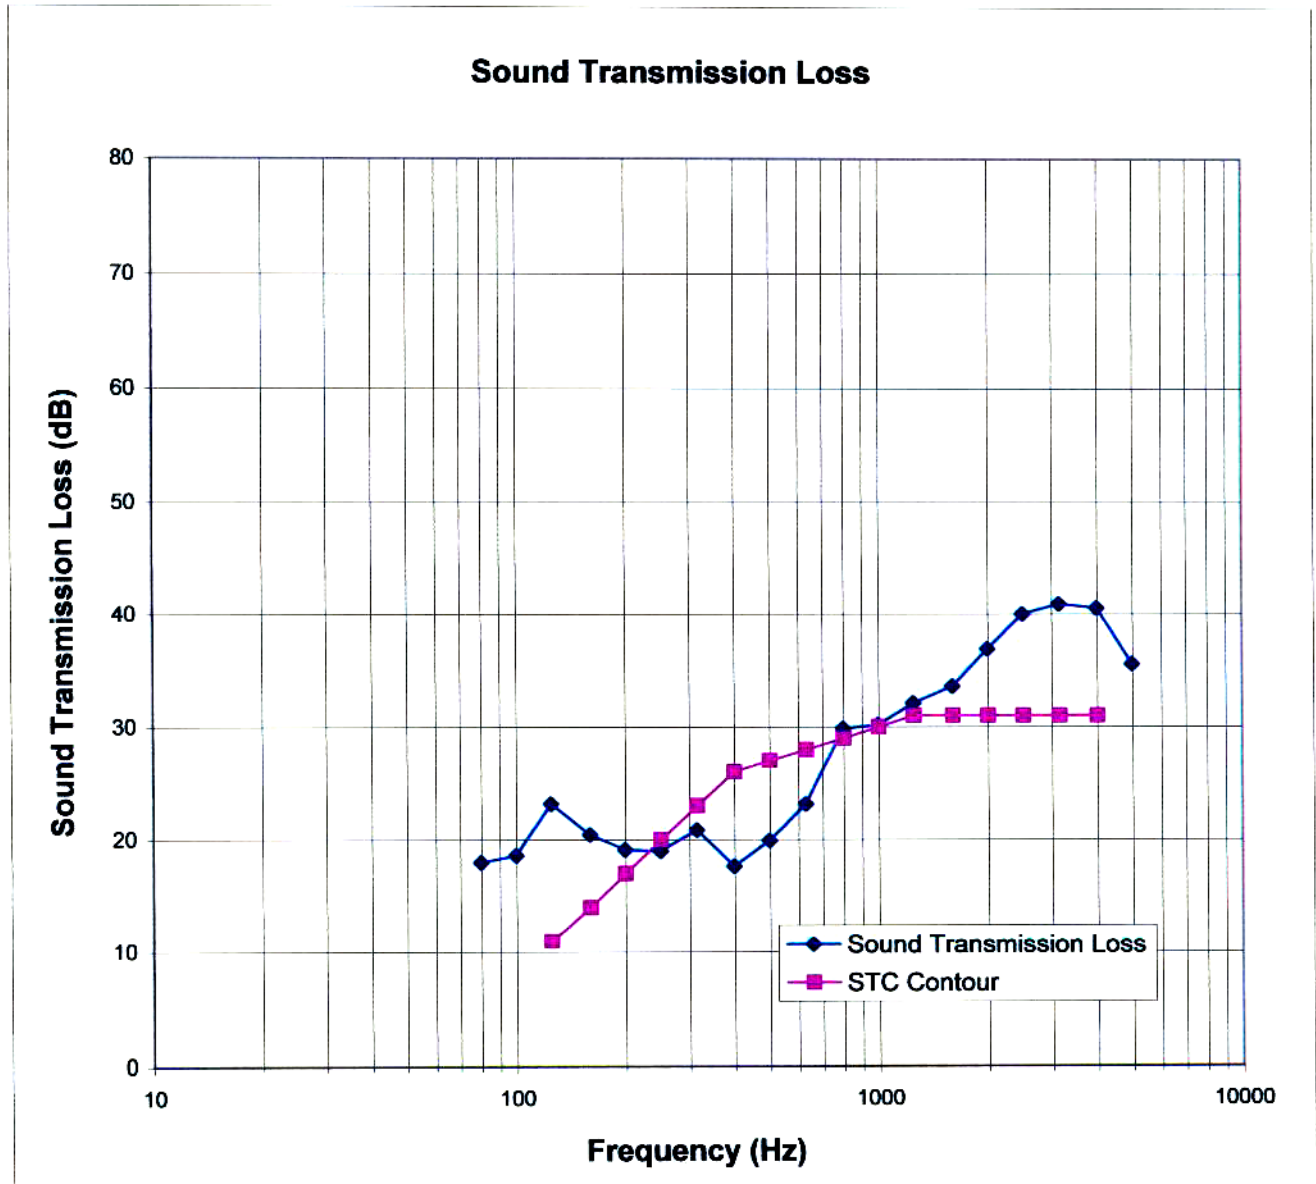
ATI No. 01-46458.01A
Client Climate Seal™
Specimen Clad Casement Window, baseline

STC Rating 27 *(Sound Transmission Class)*
Deficiencies 23 *(Number of deficiencies versus contour curve)*
OITC Rating 23 *(Outdoor/Indoor Transmission Class)*

Specimen Area 20.63 Sq Ft
Filler Area 119.37 Sq Ft
Operator Todd Kister

ATI Job File No.	Sample Description	STC	OITC
01-46458.01A	Option 1: Prime window type: Three vinyl casement windows mullled together. Prime window glazing: 5/8" IG (3/32" Annealed, 7/16" Air Space, 3/32" Annealed)	27	23
01-46458.01B	Option 2: Prime window type: Three vinyl casement windows mullled together. Prime window glazing: 5/8" IG (3/32" Annealed, 7/16" Air Space, 3/32" Annealed). Storm window - Series/Model: Three-lite in jamb. Storm window glazing: 1/8" acrylic, four sided magnet	44	28
01-46458.01C	Option 3: Prime window type: Three vinyl casement windows mullled together. Prime window glazing: 5/8" IG (3/32" Annealed, 7/16" Air Space, 3/32" Annealed). Storm window - Series/Model: One-lite in jamb. Storm window glazing: 1/8" acrylic, four sided magnet	44	31

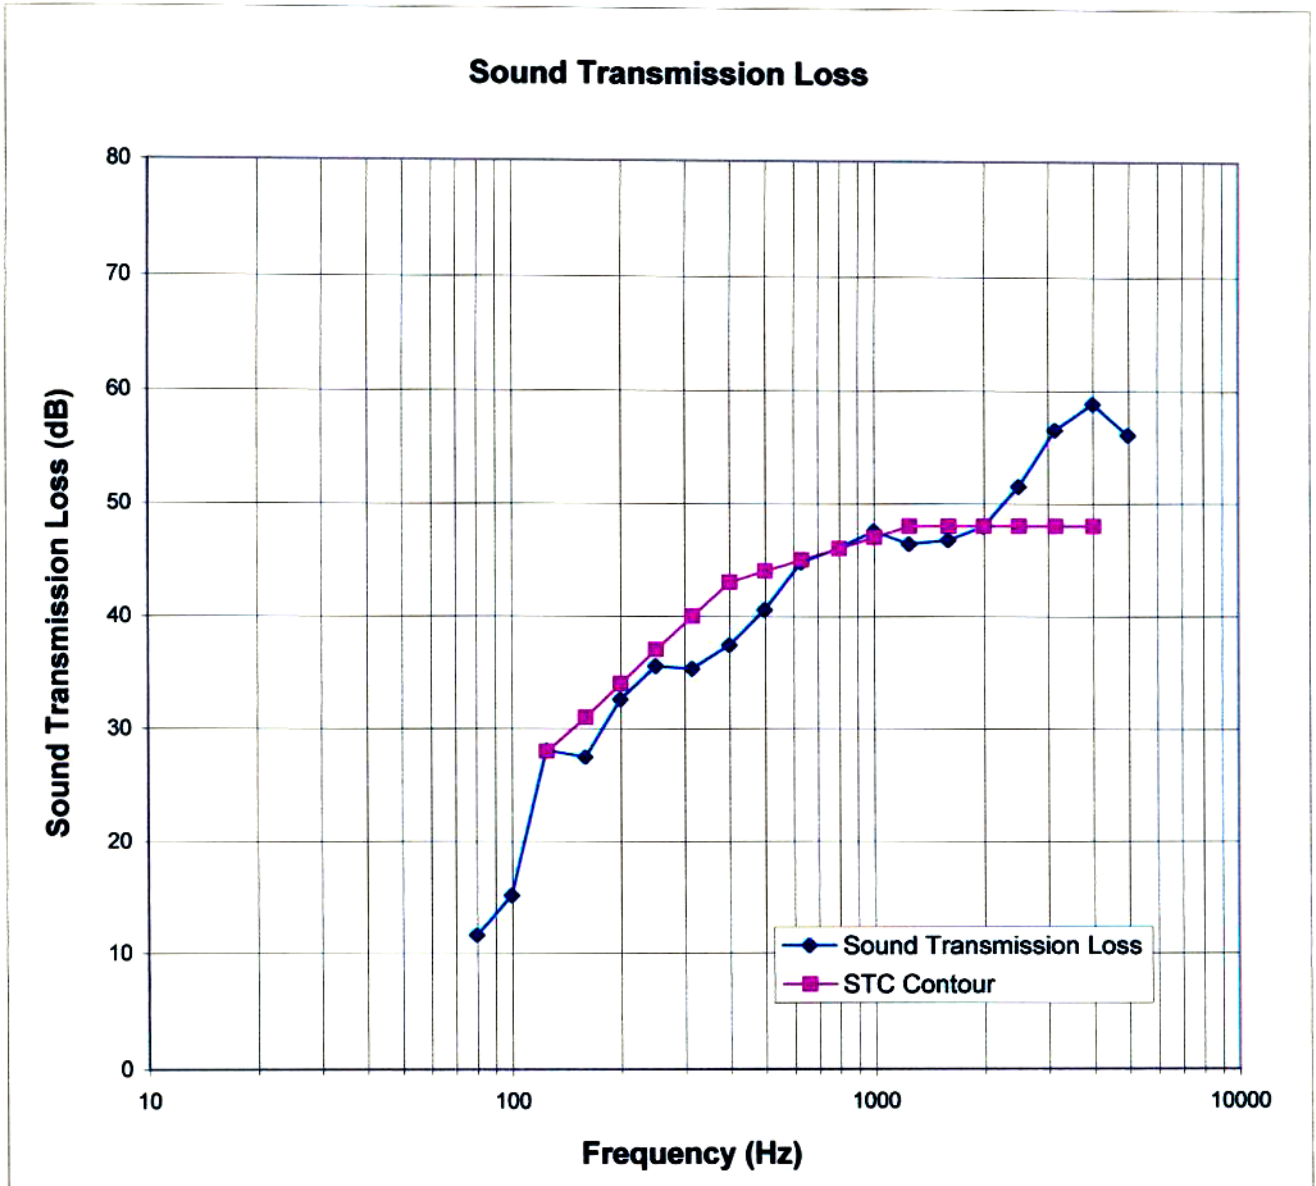
ATI No. 01-46458.01B

STC Rating 44 *(Sound Transmission Class)*
Deficiencies 23 *(Number of deficiencies versus contour curve)*
OITC Rating 28 *(Outdoor/Indoor Transmission Class)*

Specimen Clad Casement Window, in jamb storm window, 3 individual lites

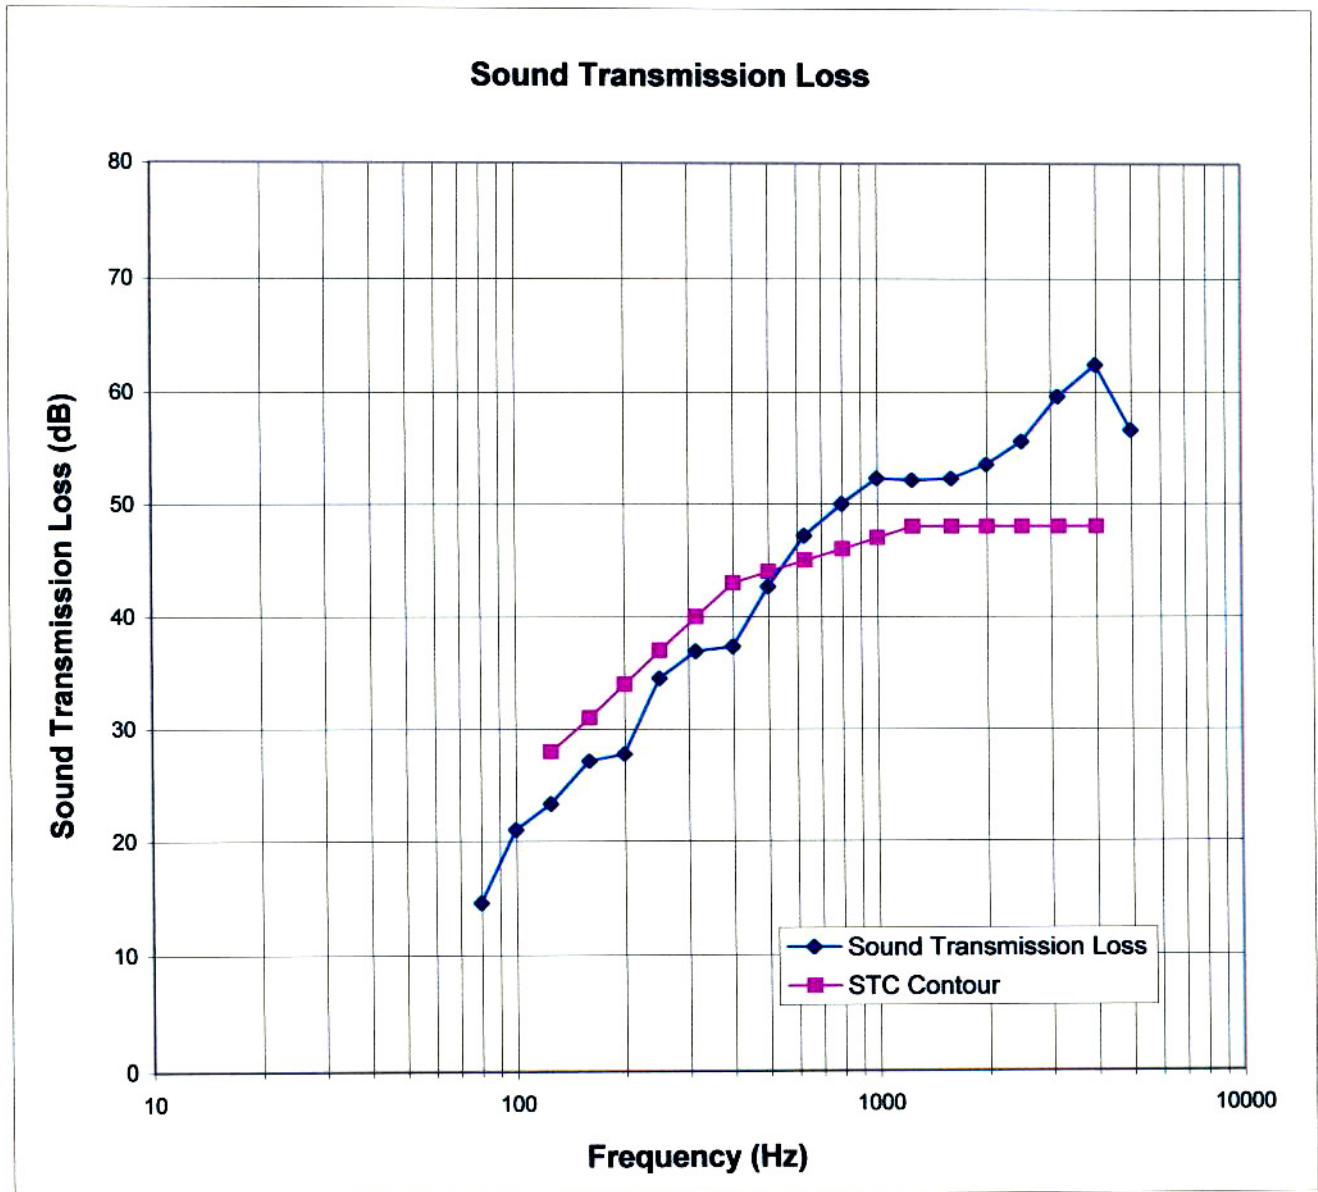
ATI No. 01-46458.01C

STC Rating 44 *(Sound Transmission Class)*
Deficiencies 27 *(Number of deficiencies versus contour curve)*
OITC Rating 31 *(Outdoor/Indoor Transmission Class)*

Specimen Clad Casement Window, in jamb storm window, 1 lites

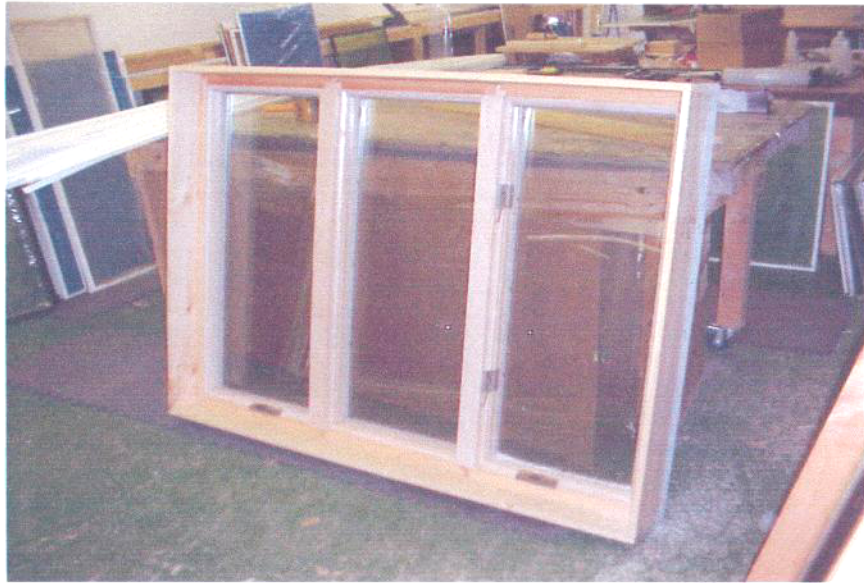
Three Casement Windows Mullered Together Before Installation

Frame	All Vents
Size	62" x 48-1/2"	19-3/8" x 46-1/2"
Thickness	5-1/2"	2"
CORNERS	Coped / Butted	Coped / Butted
Fasteners	Screws	Screws
Seal Method	Sealant	Sealant
MATERIAL	Wood / Vinyl Clad	Wood / Vinyl Clad
Reinforcement	NA	NA
Thermal Break Material	NA	NA
Daylight Opening Size (For each of the 3 lites)	NA	16" x 43-1/4"

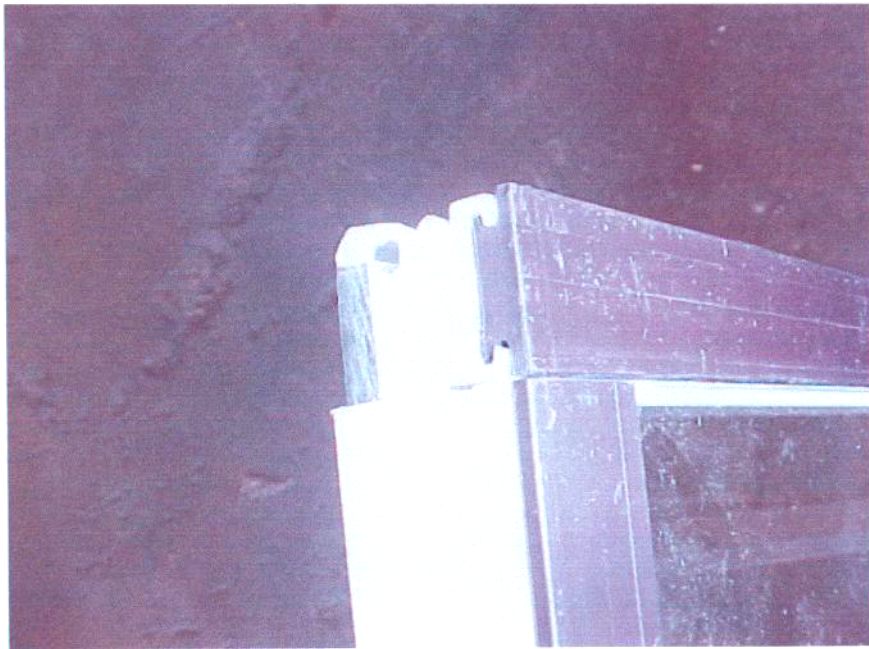
Magnetic Seal Surface of Storm Panel

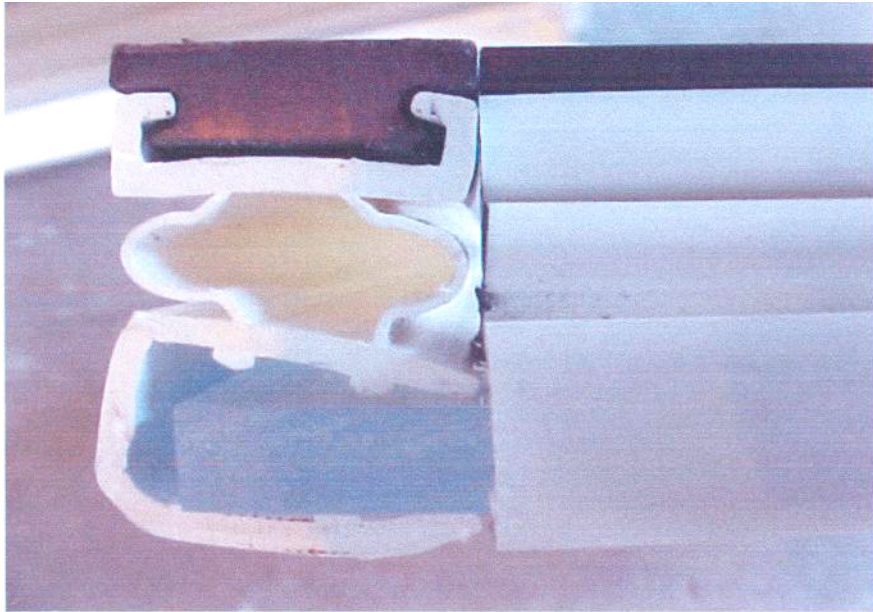
Co-extruded Dual Durometer Frame Extrusion

Frame
Size	20-1/8" x 47-3/4" (3)
Thickness	1"
CORNERS	Butted
Fasteners	NA
Seal Method	None
MATERIAL	Co-extruded, dual durometer PVC
Reinforcement	NA
Thermal Break Material	NA
Daylight Opening Size (For each of the 3 lites)	18-1/8" x 45-3/4"
