Report Date 7/7/2010

Company Energy Tight LLC  
Address 5300 Old Pineville Rd,  
Charlotte, NC 28217  
Thermographer Matt Coapman

Customer Climate Seal  
Site Address 2401 Barringer Drive,  
Charlotte, NC  
Contact Person Matt Petit

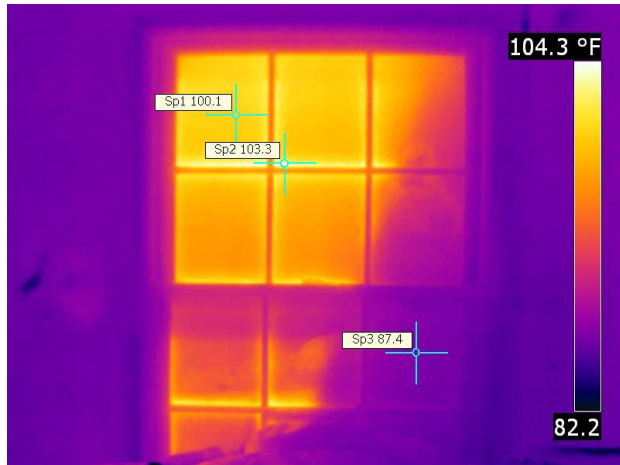
| Image Name | IR_0213.jpg |

Window before Climate Seal Installation:  
Window Pane in direct sun measures: 100.1 degrees  
Window Pane in shaded area measures: 87.4 degrees

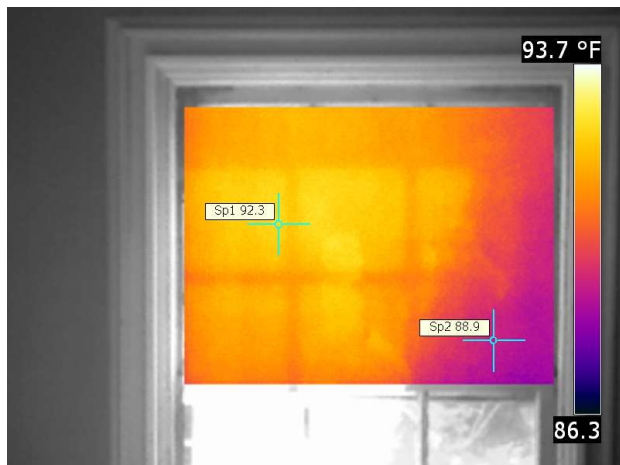
| Image Name | IR_0218.jpg |

Window after Climate Seal Installation:  
Window Pane in direct sun measures: 92.3 degrees  
Window Pane in shaded area measures: 88.9 degrees
